| <b>GPIAAF FILE No.</b><br><b>F_Inv20250903</b> | | Classification<br>Serious Accident | Type of occurrence<br>Derailment |
| Data<br>03-SET-2025 | Hora<br>18:03 | Location<br><i>Calçada da Glória</i> , Lisbon | GPS coordinates<br><a href="#">38°42'57.0"N 9°08'35.4"W</a> |
| Summary description: Derailment and subsequent collision of the Glória funicular cabins, following the rupture of the cable connection to cabin no. 1. | | | |

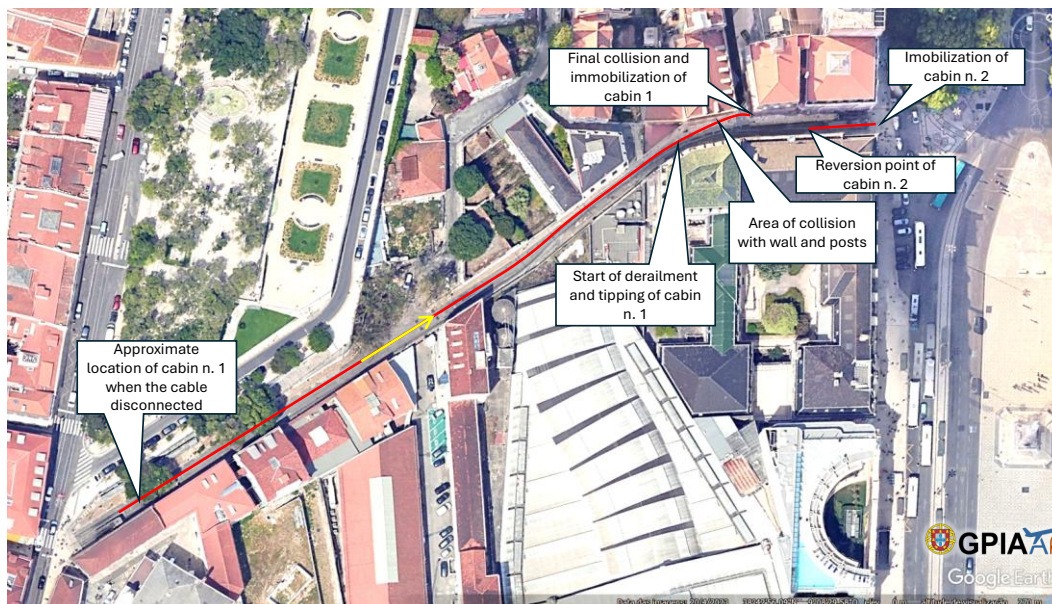
Fig. 9 - Description of events in both cabins during the accident.

Cabin No. 1, at the top of *Calçada da Glória*, continued its downward movement, suddenly increasing its speed. Less than a second after feeling the sudden acceleration caused by the cable failure, the brakeman immediately set the traction control to zero and activated the pneumatic brake valve to its maximum setting, an action that was redundant, given the automatic response triggered by the loss of electrical power. Not detecting any significant response from the vehicle, three seconds later he forcefully turned the manual wheel brake, giving it 12 full rotations and then applied downward pressure to keep it tightly engaged.

However, the extent of the forces ended up pulling apart the Z-profiles from the pavement and the cabin completely lost its guidance, colliding laterally with the upper part of the cabin against the wall of the building on the left side of the *Calçada*, which began the destruction of the wooden frame and then head-on against a streetlight pole and another supporting the funicular's overhead electrical connectors, both made of cast iron and which caused very significant damage to the structure of the cabin, and shortly thereafter ending its uncontrolled movement by striking the corner of another building.

The first impact, with the vehicle already partially tipped over, occurred at a speed estimated to be between 41 and 49 km/h, due to uncertainties in the available data, having elapsed a total of 33 seconds since the preparation for the journey, 20 seconds since the start of movement, and a further 2 to 3 seconds until the vehicle came to a complete stop.

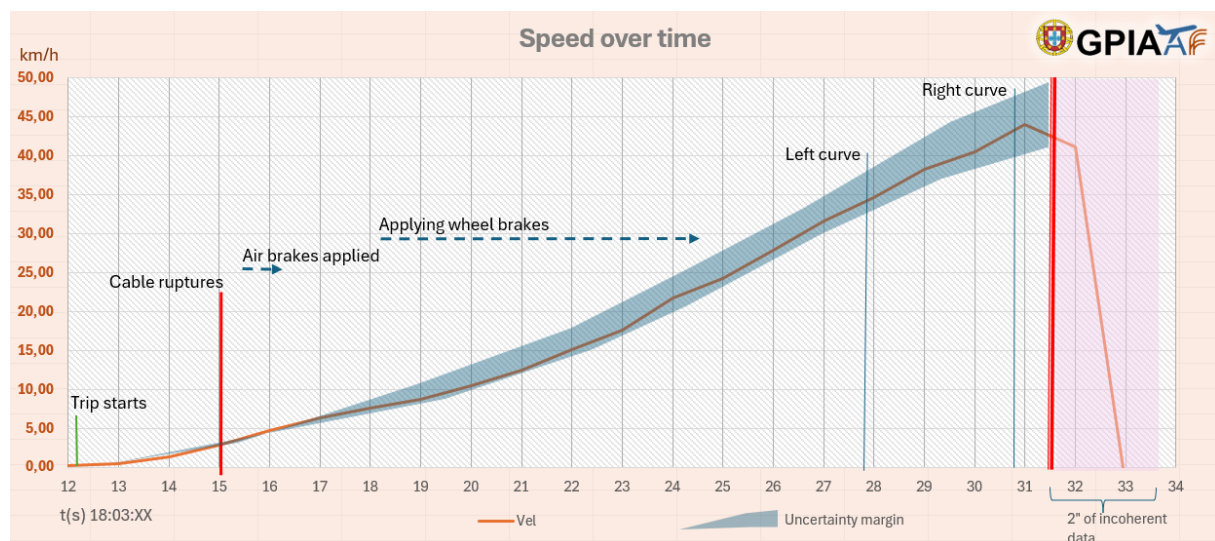
Fig. 10 - Graph illustrating speed over time and the timing of key events.

Despite this, the braking applied was not effective enough to bring the cabins to a stop, although it did have the effect of preventing the speed from increasing beyond the levels observed.

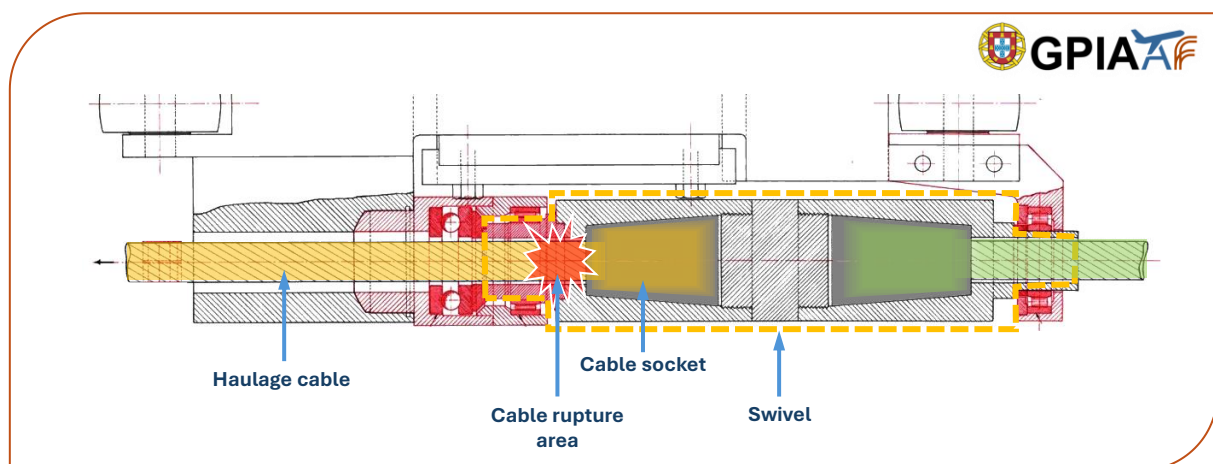
Fig. 11 - Location of the cable rupture.

The haulage cable connecting the two cabins ruptured inside cabin no.1's upper trolley cable swivel, just a few centimetres from its socketed termination.

- 1- The cable between the cabins ruptured near the termination socket on cabin no. 1, inside the swivel, after 337 days of use. The exact mechanism of material failure and causal factors still need to be determined during the ongoing investigation, following analyses to be carried out.

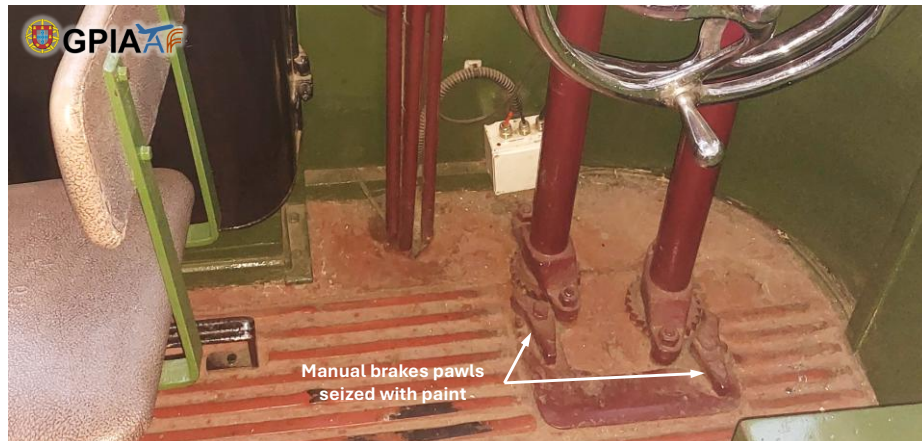
The manual brakes, operated by two concentric wheels at each driving station, did not receive much attention from the maintenance team, as according to several statements given during the investigation, they were rarely or never used by the brakemen. In fact, some of the retaining pawls of the gears, essential for their operation, were found to be stuck to the floor of the vehicles with paint.

Fig. 17 - Picture showing the manual brakes pawls seized with paint.
