| <b>GPIAAF FILE No.</b><br><b>F_Inv20250903</b> | | Classification<br>Serious Accident | Type of occurrence<br>Derailment |
| Data<br>03-SET-2025 | Hora<br>18:03 | Location<br><i>Calçada da Glória</i> , Lisbon | GPS coordinates<br><a href="#">38°42'57.0"N 9°08'35.4"W</a> |
| Summary description: Derailment and subsequent collision of the Glória funicular cabins, following the rupture of the cable connection to cabin no. 1. | | | |

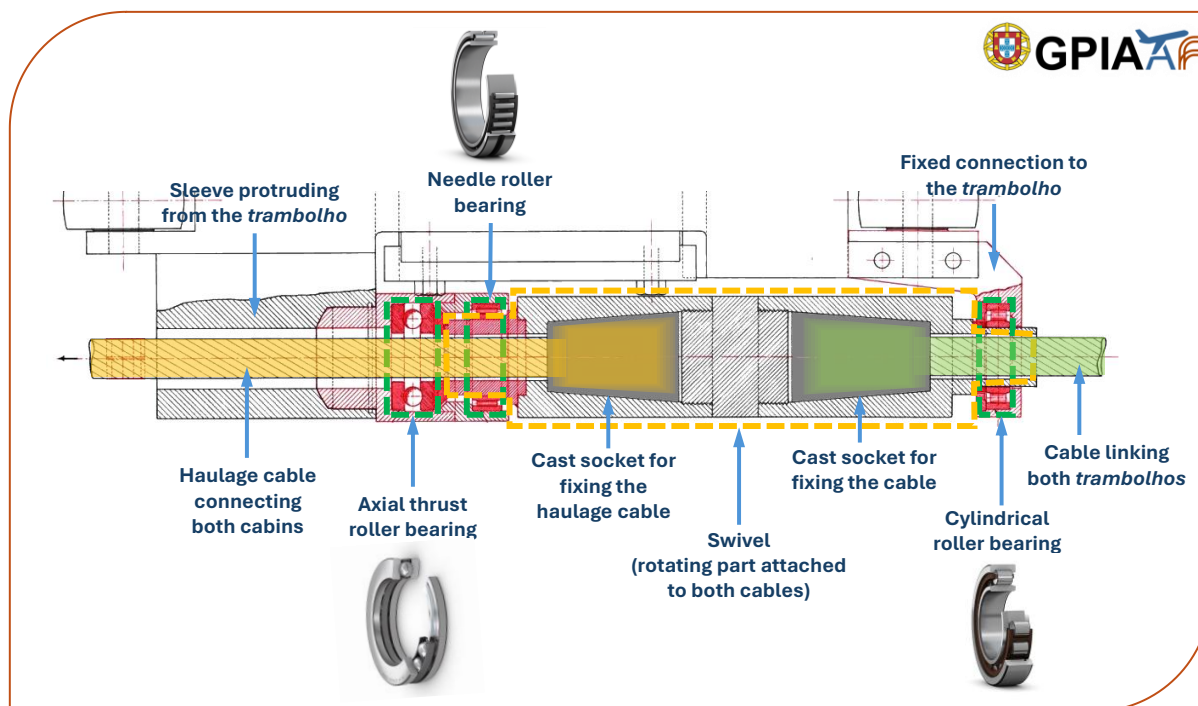
Fig. 3 - Composition of the swivel at the upper trolley (*trambolho*), where the haulage and the linking cable between the trolleys are attached.

The haulage cable connecting the two cabins ruptured inside cabin no.1's upper trolley cable swivel, just a few centimetres from its socketed termination.

A macroscopic analysis of the fractured ends of the broken strands reveals ruptures of varying ages, indicating that the failure occurred progressively over time and involved multiple fracture types. The metallurgical examinations to be carried out during the investigation will clarify the failure mechanisms involved. As is evident from the diagram above, the fracture location was not visually accessible without disassembly of the swivel.

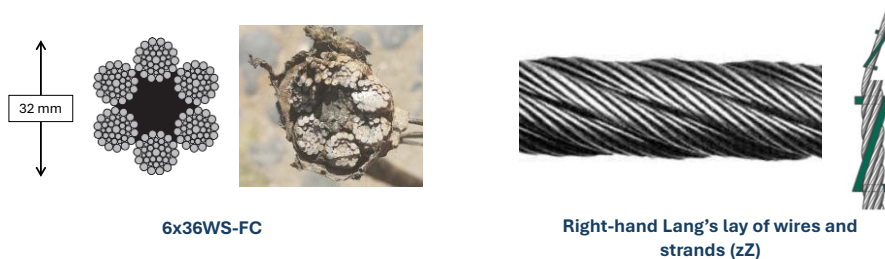
Fig. 14 - Illustration of the 6x36WS-FC cable and right-hand Lang's lay configuration.

It consists of a steel cable with a nominal diameter of 32 mm, type 6x36WS-FC gr1960 zZ, that is, composed of six strands, each consisting of 36 steel wires of varying diameters with a tensile strength of 1960 MPa, arranged within each strand in a Seale-Warrington configuration, and laid in a right-hand Lang lay around a synthetic fibre core.

This type of cable is commonly used and is not unusual for funicular applications. Its use for this purpose is specified in the standard PT EN 12385-8:2014 - Steel wires. Safety. Part 8: Traction wire ropes and haul ropes for installations intended for persons.

unsuitable for use with swivels. According to this classification, the 6x36WS-FC rope is not rotation-resistant and must not be used with swivels, as was clearly stated in the inspection certificate provided by the manufacturer for the ropes delivered to CCFL, unless its use is supported by a specific technical study assessing its behaviour under the intended conditions.

**Accordingly, it must be stated that, at this stage, it cannot be concluded whether the use of this non-compliant cable contributed to the failure that occurred after 337 days in service, nor what role, if any, it may have played. It is, however, certain to the investigation that other contributing factors must necessarily have been involved.**

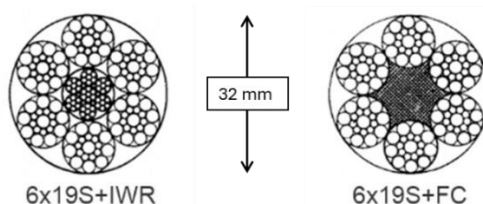
Fig. 15 - Types of cable permitted under the CCFL specification for the Glória Funicular

The 6x19S-IWRC gr1770 zZ cable, with a steel core, was the type traditionally used by CCFL on the Glória and Lavra Funiculars for several decades. Its performance was well understood and had performed reasonably satisfactorily.

The 6x19S-FC gr1770 zZ cable, with a synthetic fibre core, was accepted as an alternative based on a recommendation from an accredited and specialised entity in the field. CCFL adopted and incorporated it into the specification in view of potential difficulties in sourcing the usual cable, a situation that was already occurring at the time the specification was drawn up.
